# Mill Seat Landfill Expansion

## Draft Supplemental Environmental Impact Statement Attachment E

**PHASE 1 BOG TURTLE HABITAT SURVEY**

**MILL SEAT LANDFILL**

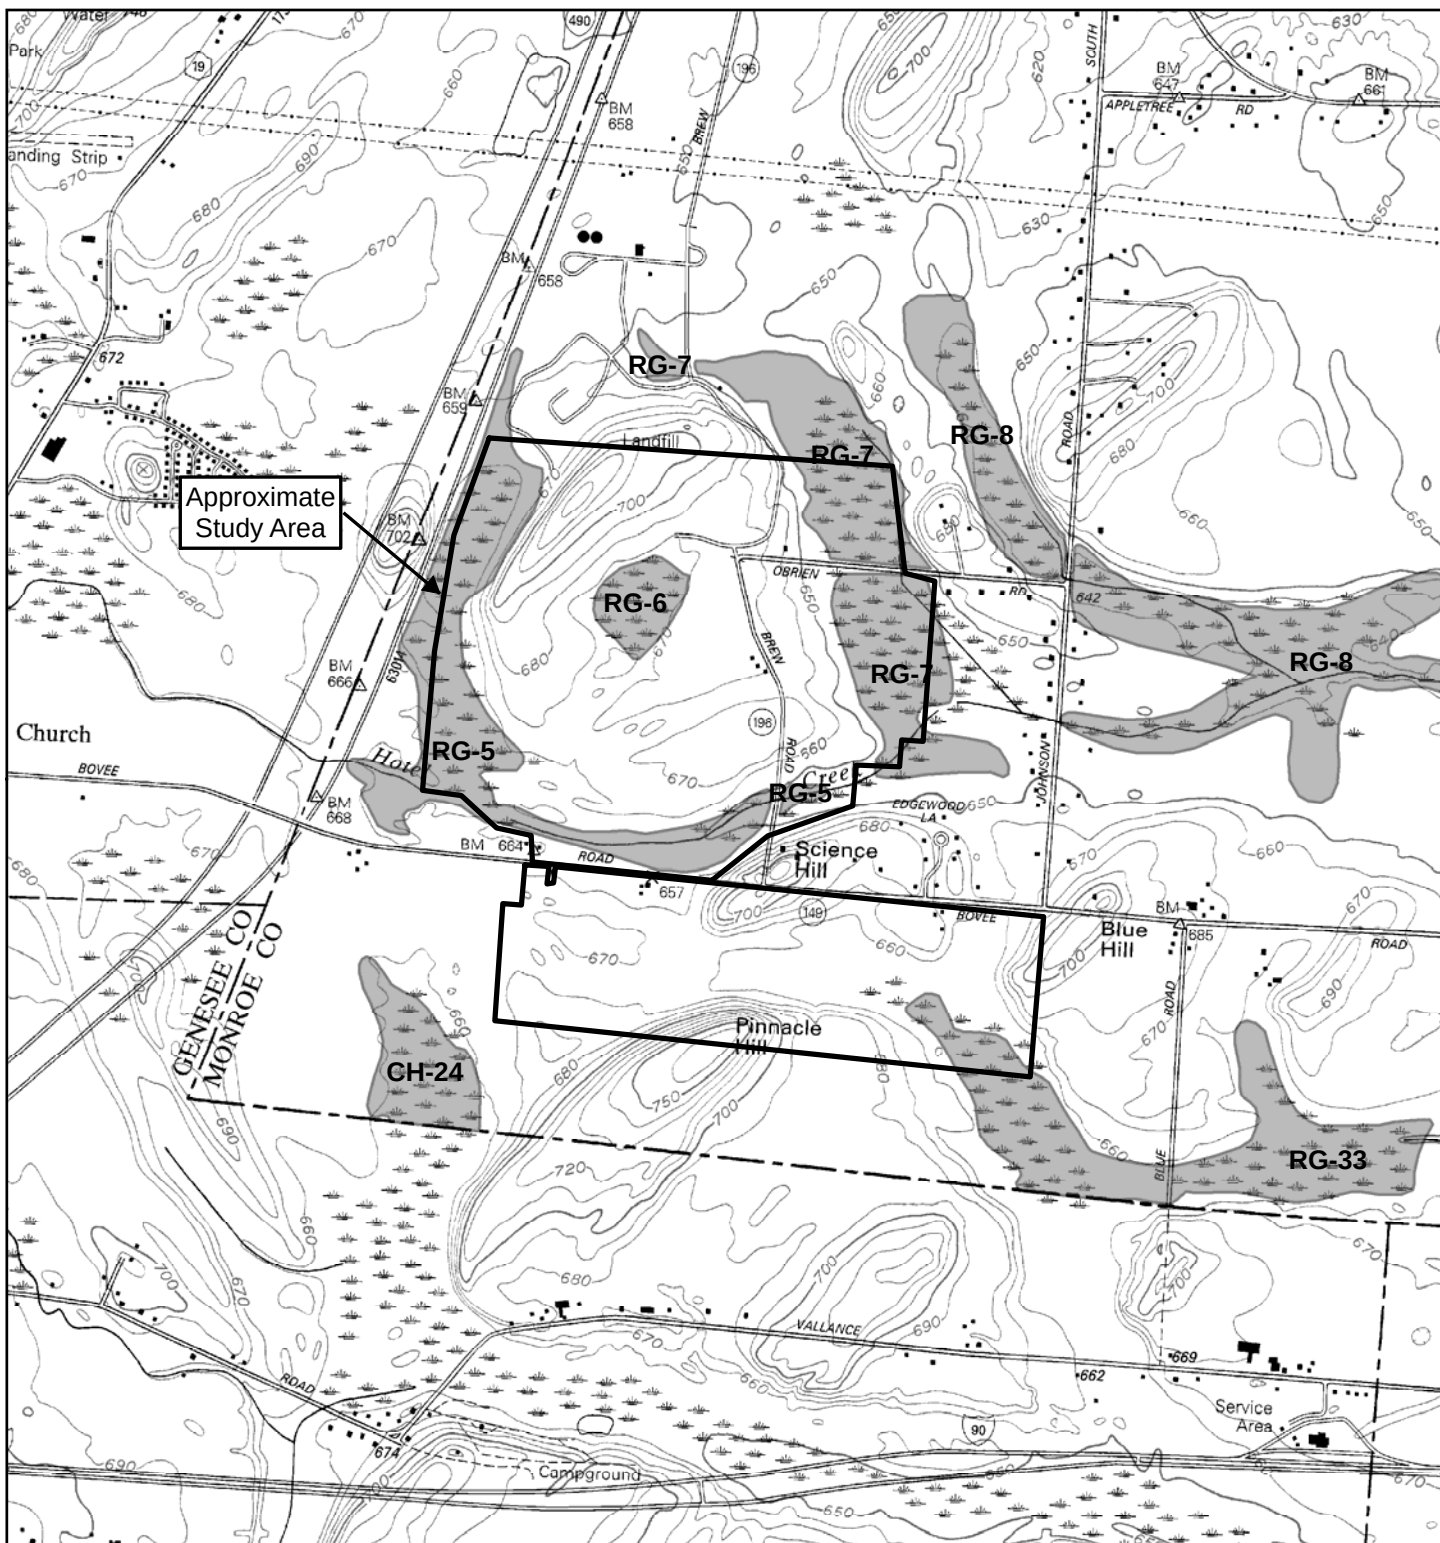
**Figure 2. NYS Freshwater Wetlands Map**

NYS Department of  
Environmental Conservation  
[cugir.mannlib.cornell.edu](http://cugir.mannlib.cornell.edu)

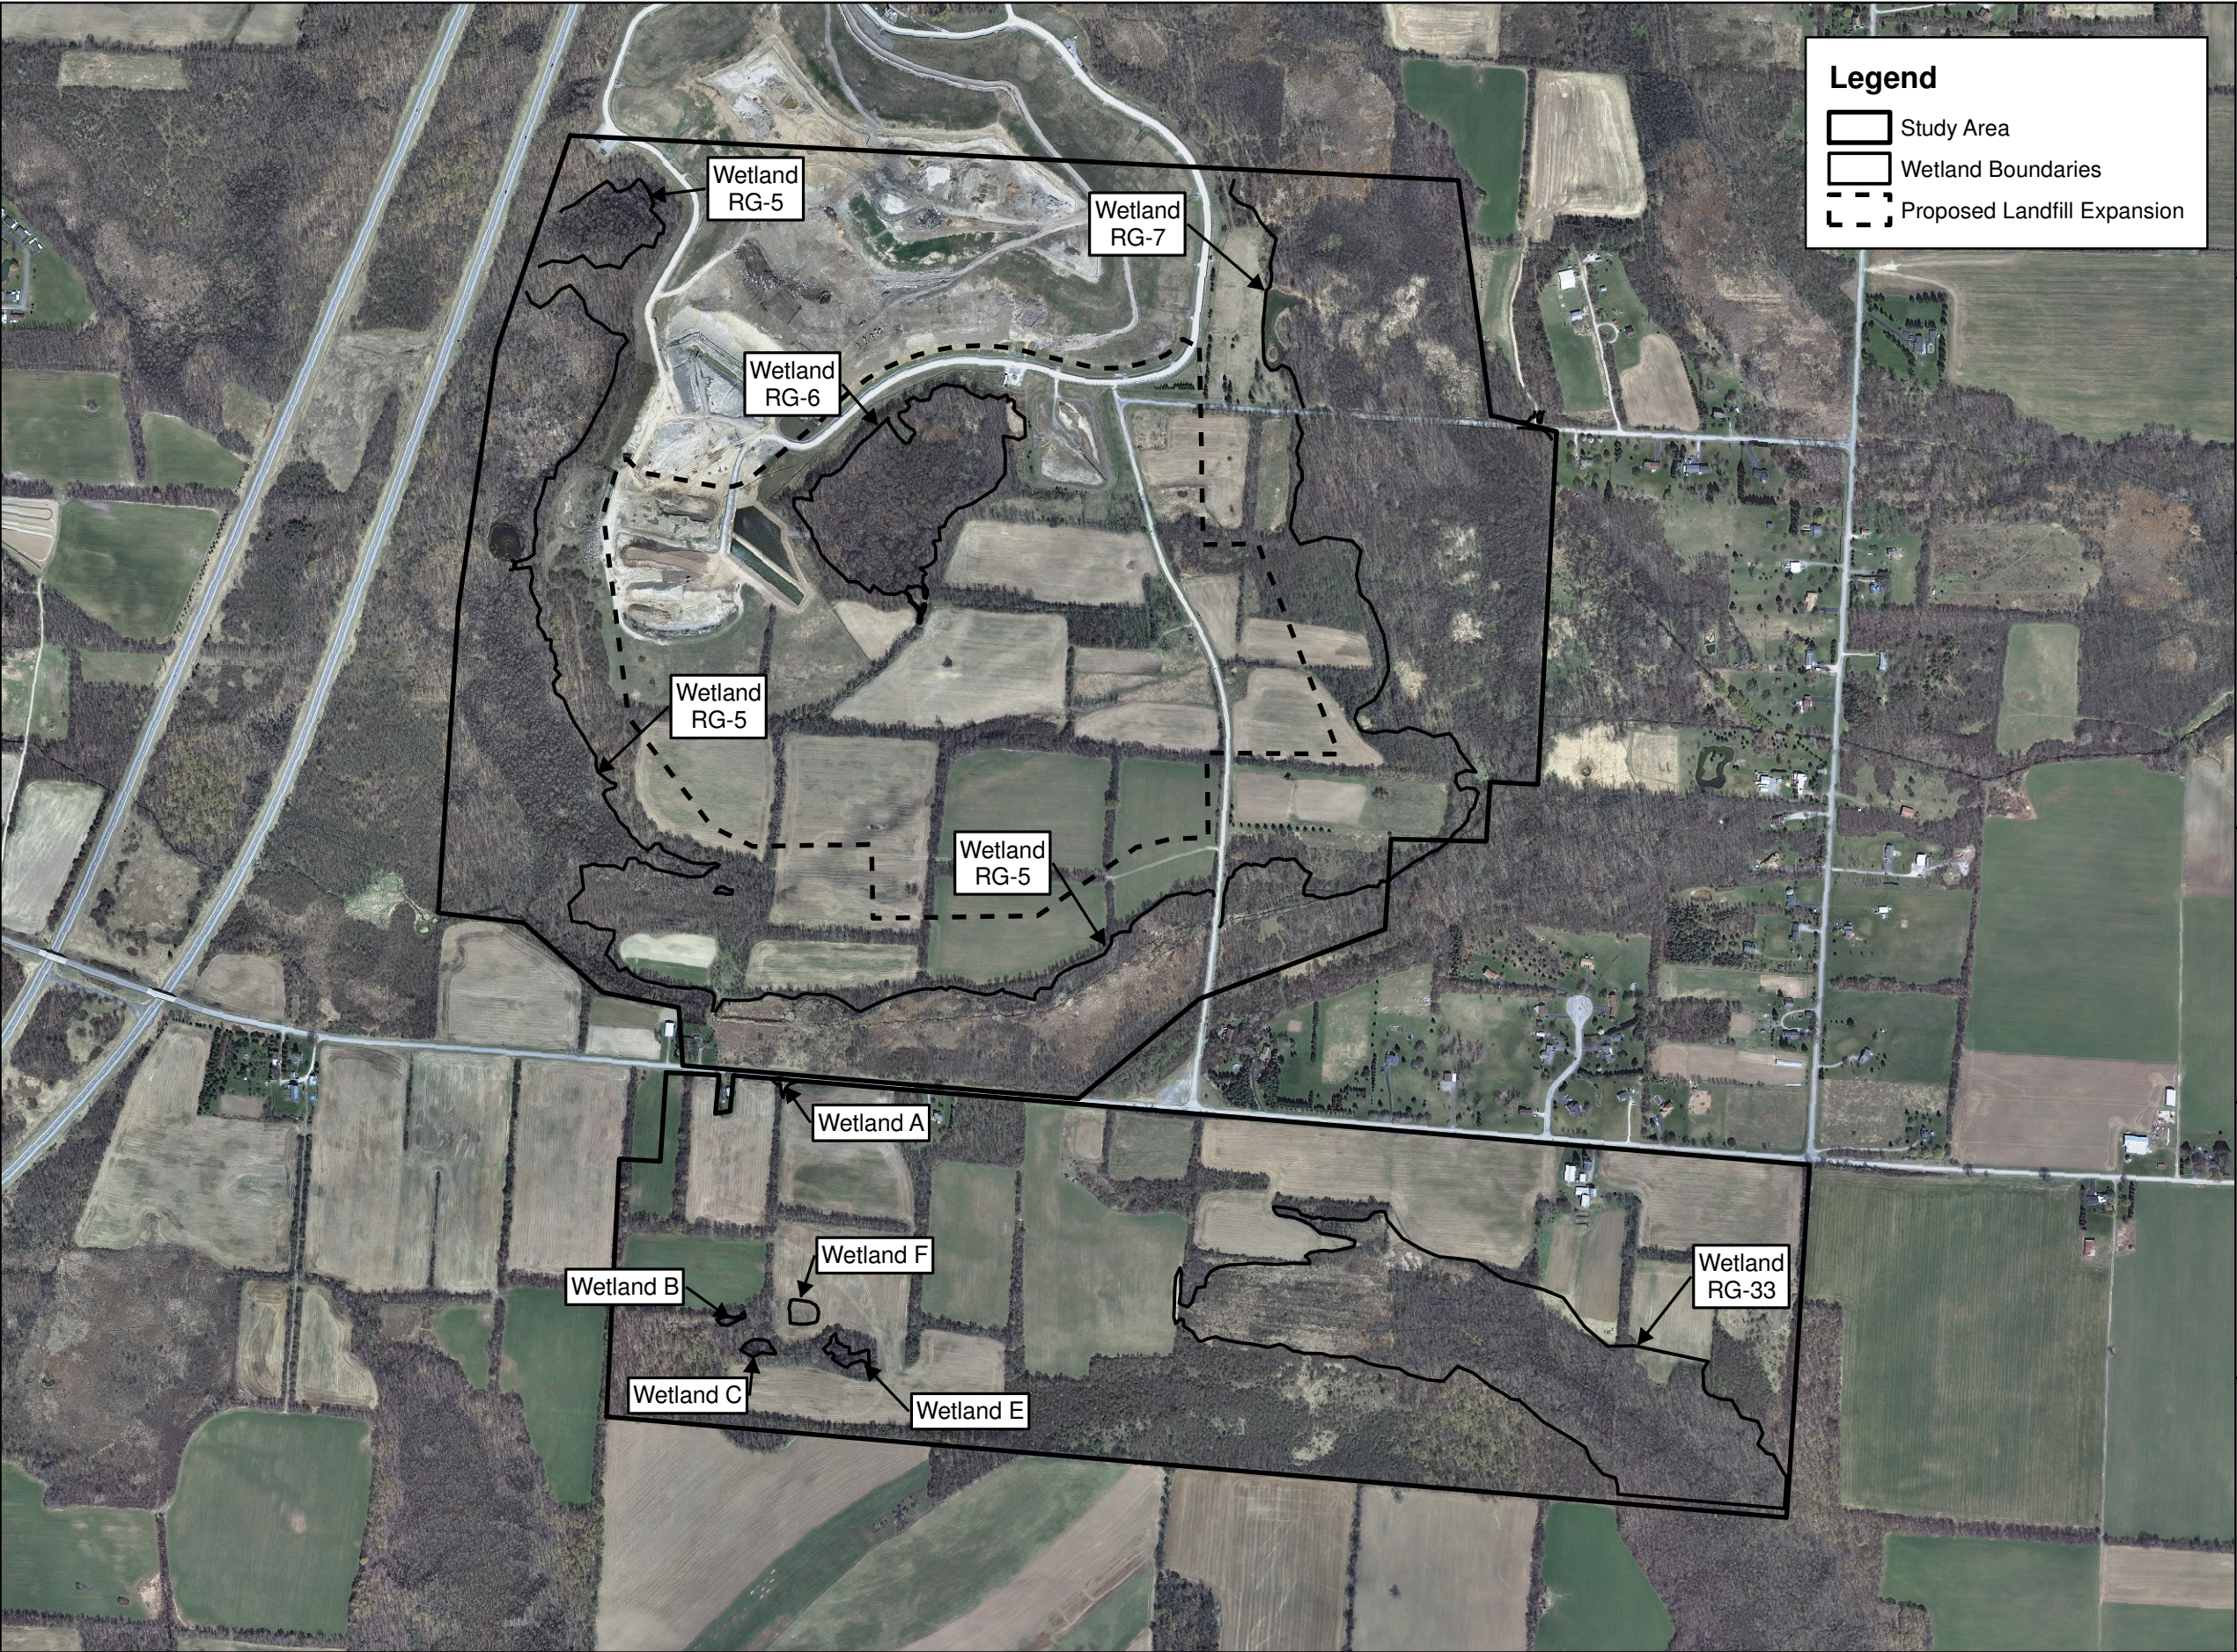
**Figure 4.**  
**Aerial Photograph  
of Study Area  
with Wetlands  
and Proposed Landfill  
Expansion Area**

- Study Area
- Wetland Boundaries
- Proposed Landfill Expansion

NYSDEC wetland (RG-6) is within the proposed landfill expansion area (see Figure 4). In the process of securing permits to perform the landfill expansion, endangered and threatened species must be addressed. Bog turtle, a federally threatened species, was indicated as a species with potential to occur at this site. Therefore the wetlands on site must be assessed for their potential suitability to serve as habitat for bog turtle. Bog turtle natural history and survey methods for the habitat assessment are provided in the following sections.

Wetland boundaries were identified using the mapping provided by B&L (Figure 4). Wetlands within the study area were walked by TES during field efforts performed on December 23, 2013 and January 13, 2014. Observations were made within each wetland sufficient to characterize the wetland and assess each for its overall suitability for bog turtles. Habitat evaluation field forms (data sheets) for Phase 1 bog turtle surveys were developed by the USFWS in conjunction with the Pennsylvania Fish and Boat Commission (PFBC). In 2009, the field forms were modified by TES bog turtle surveyors to reflect Prairie Peninsula/Lake Plain field conditions. One data sheet was completed for each section of wetland TES deemed appropriate to characterize the habitat accurately, and representative photographs were taken. The photographs and data sheets are provided in Appendix A and B, respectively.

TES assessed habitat in four NYSDEC wetlands (RG-5, RG-6, RG-7, and RG-33) and five additional delineated wetlands present within the study area (Figure 4). Data was collected throughout all the wetlands within the study area and some wetlands were large enough to warrant multiple data sheets. Surveys were performed outside of the growing season and therefore, the number of species present was significantly lower than they would be at other times of the year. A total of 18 data sheets were completed and can be found in Appendix B. None of the wetlands within the study area displayed characteristics indicating the potential for bog turtle habitat.

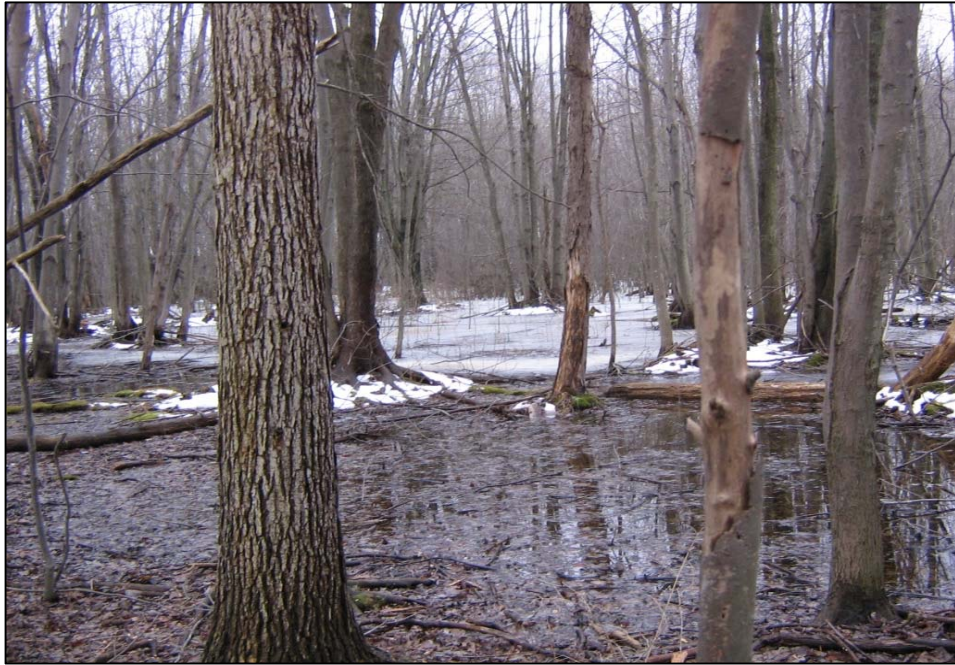
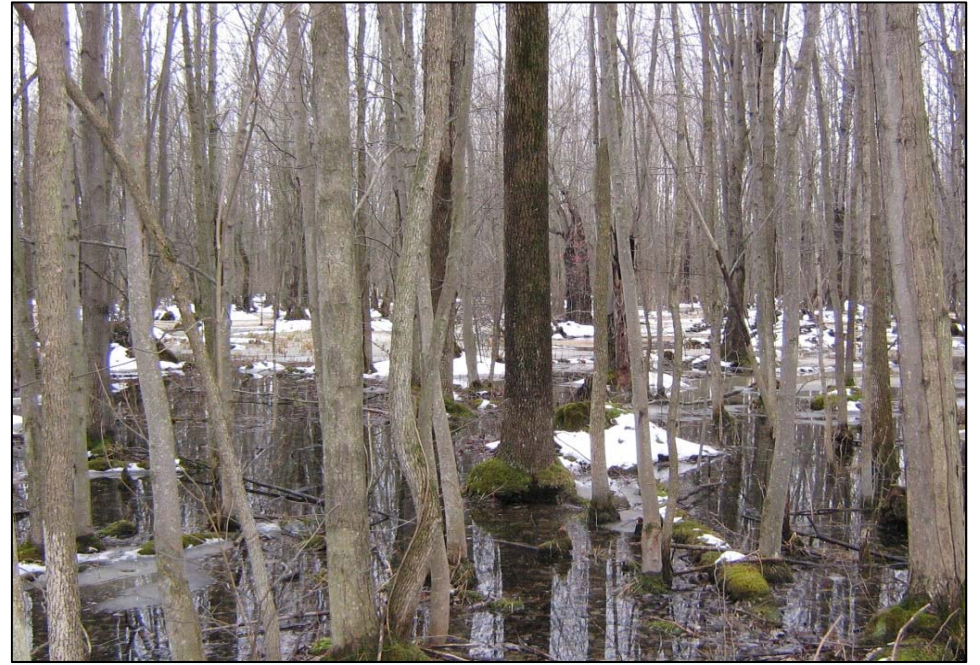
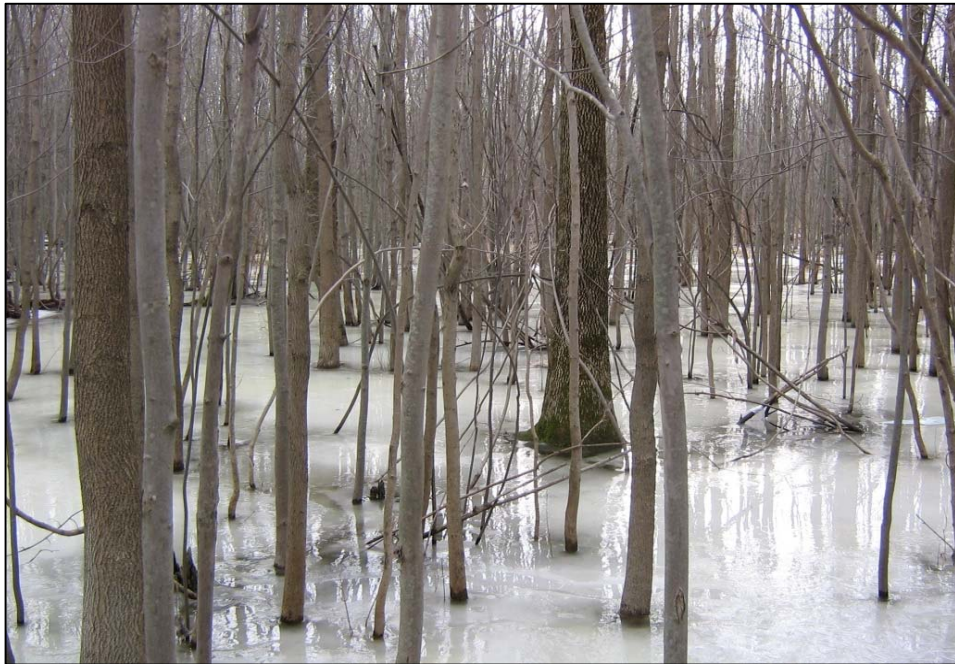
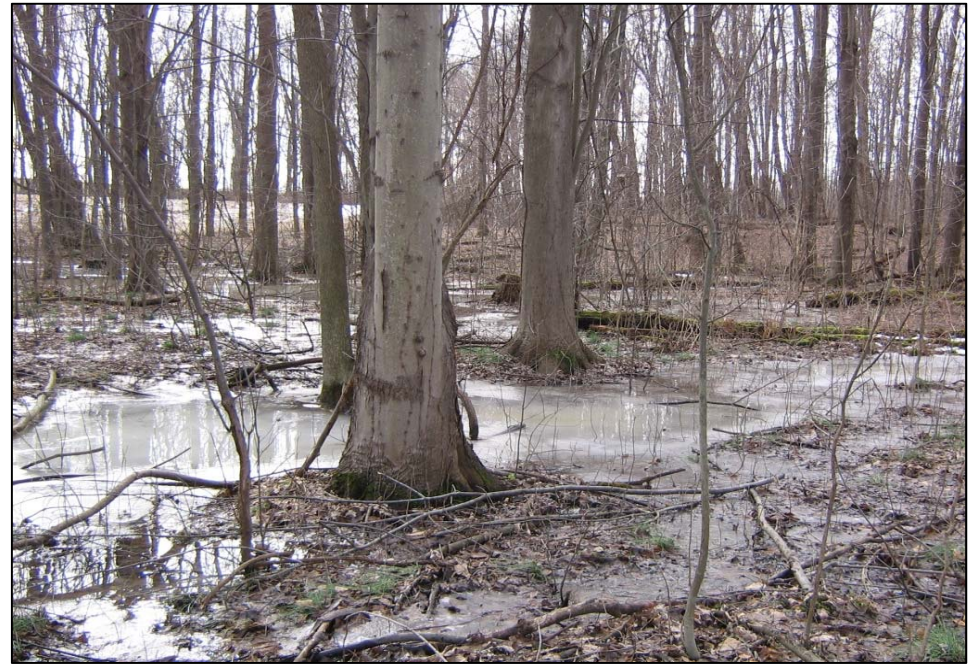
Representative Photo of Deciduous Forest Wetland

Deciduous forest wetlands present on-site were dominated by silver maple (*Acer saccharinum*) and green ash (*Fraxinus pennsylvanica*) in the overstory. Dominant plants in the

mid and understory included; sensitive fern (*Onoclea sensibilis*), winterberry holly (*Ilex verticillata*), and green ash.

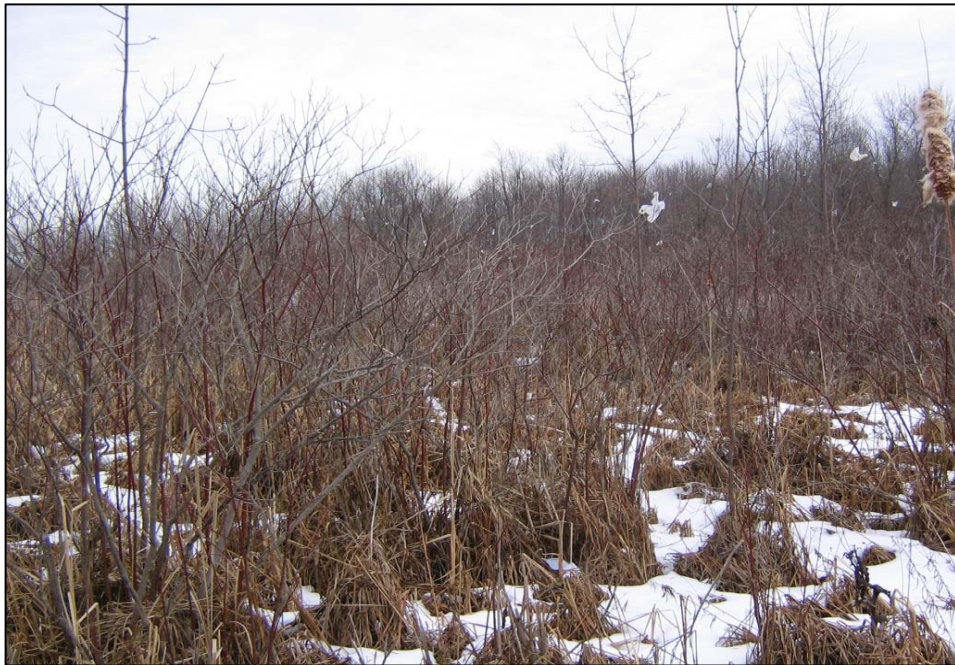
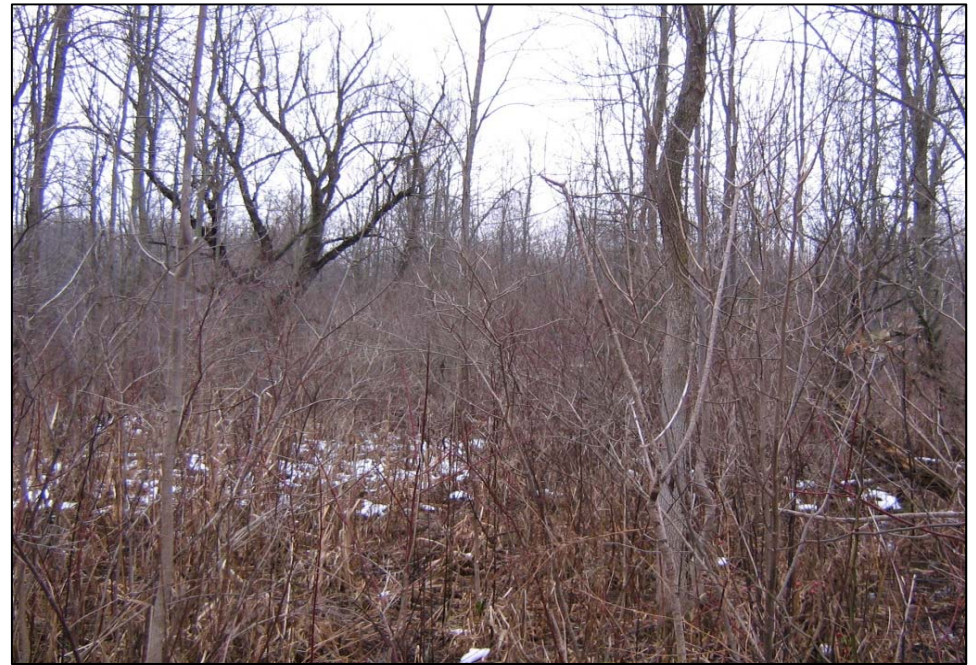
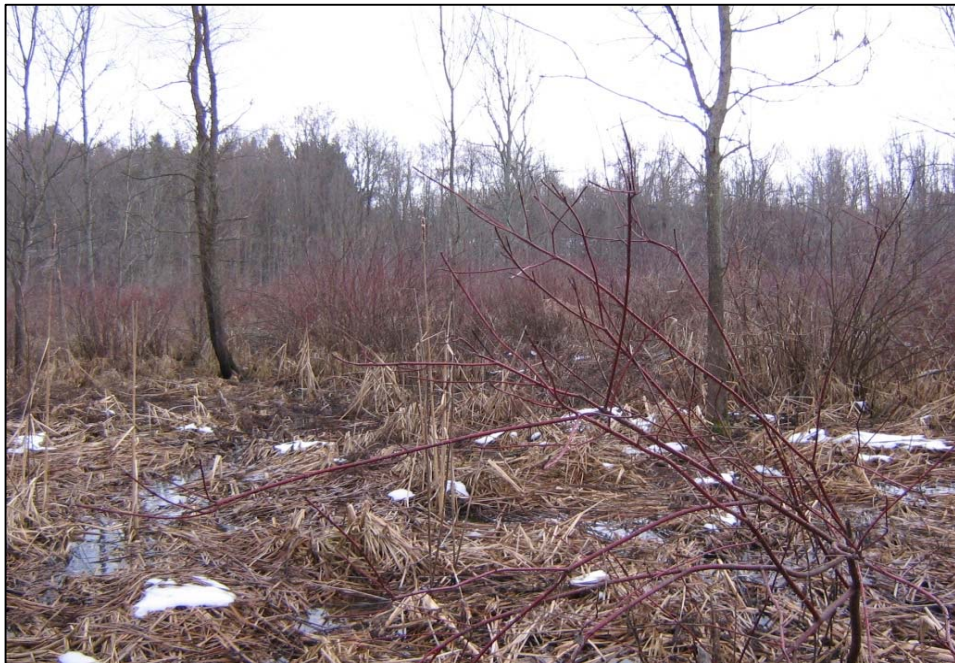
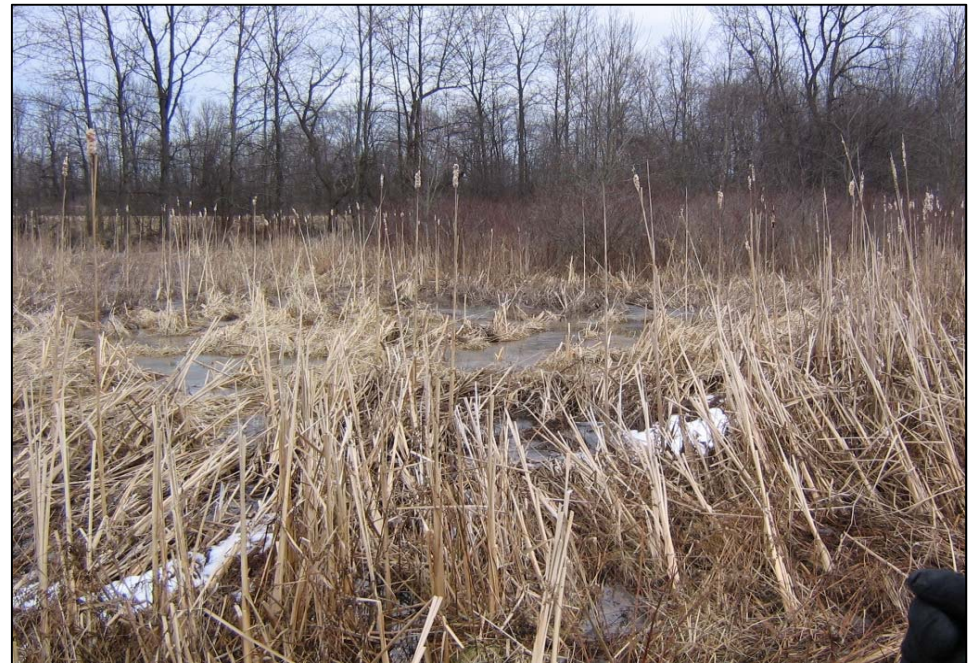
Representative Photo of Scrub-Shrub Wetland

Representative Photo of Emergent Wetland

The site contained many areas of scrub-shrub and emergent wetland as well, especially along stream corridors. Dominant herbaceous species in these areas included cattail (*Typha latifolia*), common reed (*Phragmites australis*), and rushes (*Juncus torreyi* and *J. canadensis*). Dominant shrub species present included; multiflora rose (*Rosa multiflora*), silky dogwood (*Cornus amomum*), and red-osier dogwood (*Cornus sericea*).
